Sun Blade X6250 Server Module

Product Notes

Part No.: 820-1186-33,
March 2011

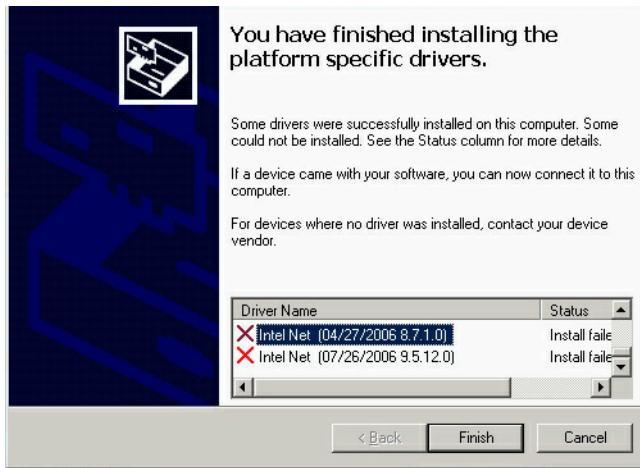
FIGURE 5-1 Sample of Error Message

Upon completing the platform specific drivers and optional components update, an error message states that some drivers could not be installed. [FIGURE 5-1](#) shows an example.

This message can be ignored.
