# Sun Ultra™ 24 Workstation Product Notes

Part No. 820-2478-17  
June 2009, Revision A

# Workstation Product Notes

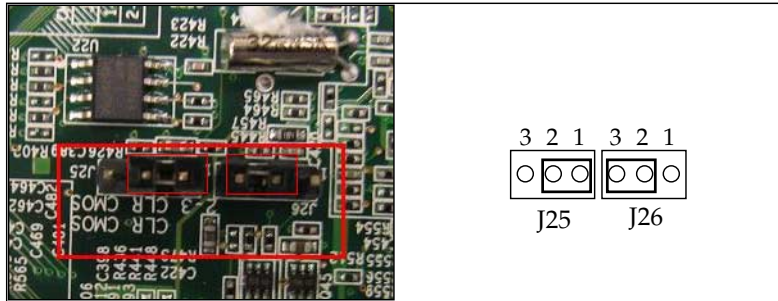
**FIGURE 1** Photograph and a Graphic Representation of Jumper J25

J25 is a three position jumper located near the inside end of slot PCI 0. Jumper J25 is located next to jumper J26. [FIGURE 1](#) shows a photograph and a graphic representation of the location of J25 and J26, the pin numbering, and the jumper cap residing at the factory setting.

5. **When the update is finished, power off the workstation using the power switch on the rear panel.**
6. **Remove the side cover, and locate jumper J25 on the workstation motherboard.**

7. Pull the jumper cap on J25 from pin position 1-2 (factory setting) and move the cap to pin position 2-3. [FIGURE 2](#) shows the jumper cap on J25 set to pin position 2-3.
