# Sun Blade™ X6220 Server Module Product Notes

Part No. 820-0048-18  
May 2009, Revision A

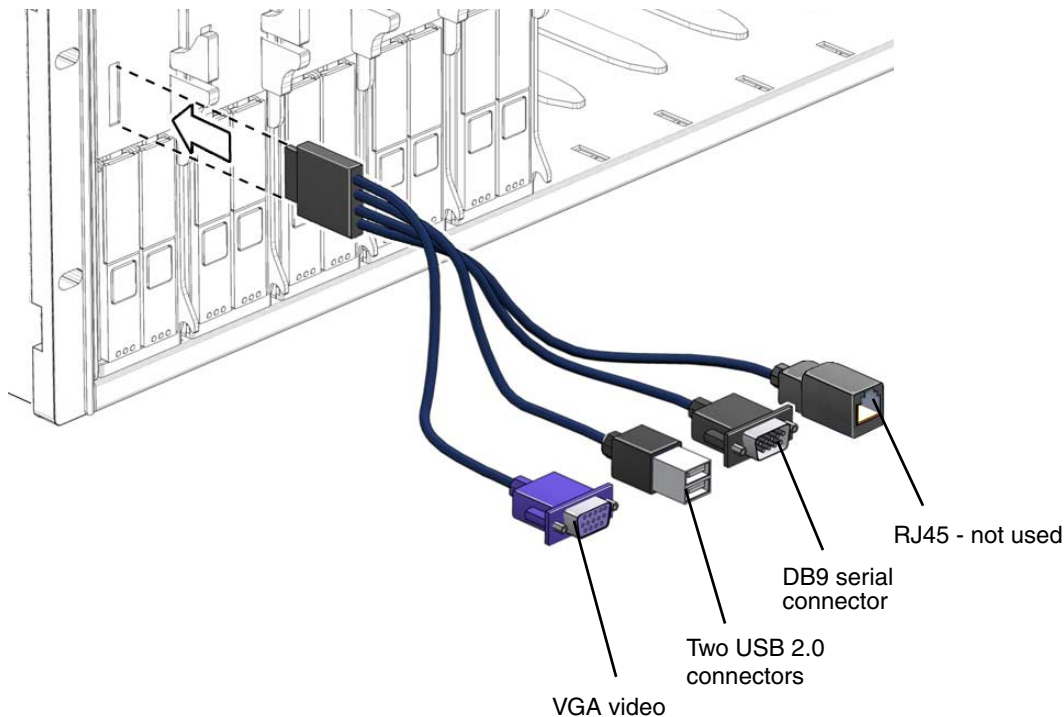
**FIGURE 2-1** Four-Connector Dongle Cable

- Four-connector cable dongle: This dongle has dual-USB, RJ-45, VGA, and DB9 connectors. See [FIGURE 2-1](#).
  - VGA connector: This connector can be used for setting up a video monitor to the server module.
  - USB connectors: These connectors are used to connect USB devices to the server. For example, an external CD drive can be attached to the server module with this connector.
  - DB9 serial connector: This connector is used to connect to a serial console. A DB9 to RJ-45 adapter is also included with the chassis to enable RJ-45 serial connections.
  - RJ-45 connector: This connector is not used for this server module.

**Caution** – The cable dongle is for temporary connections only. The cable dongle has not been evaluated for electromagnetic compatibility (EMC). The cable dongle or server module connectors could be damaged by closing rack doors or other impacts. Remove the cable dongle during normal system operation.

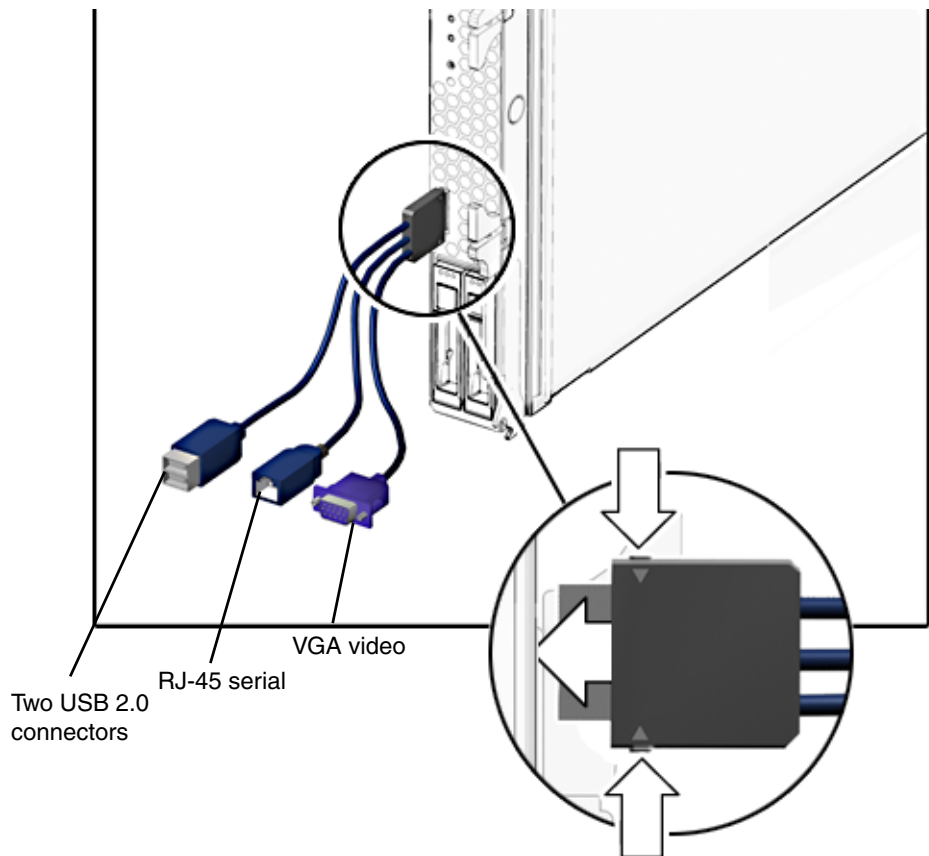
**FIGURE 2-2** Three-Connector Dongle Cable

- Three-connector dongle cable: This dongle has dual-USB, RJ-45 and VGA connectors. See [FIGURE 2-2](#).

- USB connectors: These connectors are used to connect USB devices to the server. For example, an external CD drive can be attached to the server module with this connector.
- RJ-45 connector: This connector is used to connect to a serial console. For example, you can use this to connect to the ILOM CLI.
- VGA connector: This connector can be used for setting up a video monitor to the server module.
