Sun Fire™ B1600 Chassis and B100s, B100x, and B200x Blade Product Notes

Part No. 817-5626-12
May 2004, Revision A

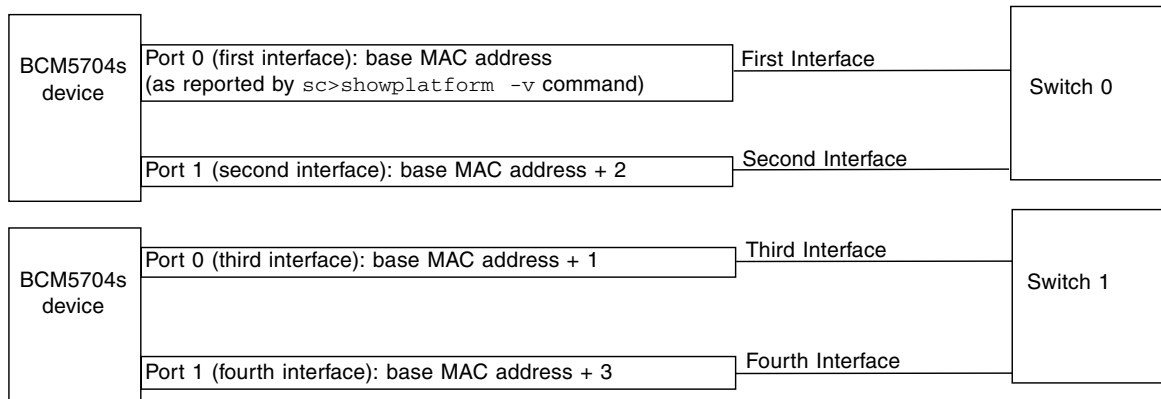
FIGURE 3-1 The Network Interfaces on a B200x Blade

The B200x blade has two dual-port BCM5704s Gigabit Ethernet chips. Each individual port is connected to one of the Ethernet switches in the B1600 chassis, and the BIOS takes responsibility for assigning the MAC addresses to the Ethernet ports (see FIGURE 3-1).

From [FIGURE 3-1](#) and [FIGURE 3-4](#) you can see that the bge0 and bge1 interfaces have even MAC addresses and are connected to Switch 0 (SSC0), and that the bge2 and bge3 interfaces have odd MAC addresses and are connected to Switch 1 (SSC1).
